Engineering Specialty Report

Project Summary

Over the years, Joseph Sears School in Kenilworth, IL, has experienced various amounts of water intrusion in the crawl space and/or utility tunnel. Most recently, during the July 23, 2011 rain event approximately 6.2” fell in a 24-hour period. The results of this rain event were flooded roads in the Village of Kenilworth, sewer backups in the School, and flooding in the School utility tunnel and auditorium. As a result of this event, Kenilworth School District 38 contracted with Gewalt Hamilton Associates, Inc. (GHA) to investigate any major single sources of storm water in the crawl space/utility tunnel.

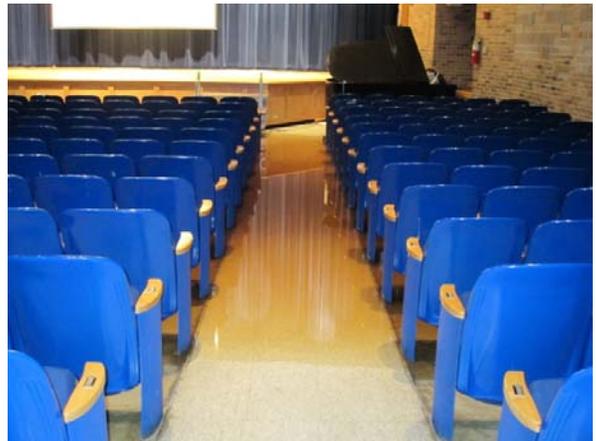
Figure 2 – Auditorium Flooding

- At least ½ inch depth of water in low spot of auditorium. (See Figure 2)
- Utility Tunnel half full of water. (See Figure 3)
- Sewage backup in utility closet next to Cafeteria. (See Figure 4)

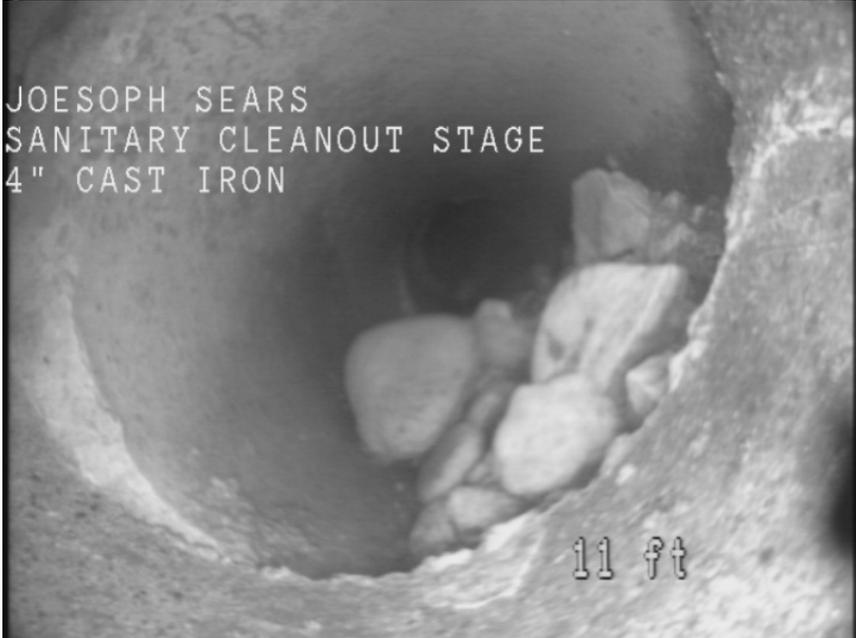
Sewer Observations	
Legend: CO = Cleanout MH = Manhole CB = Catch Basin	
Pipe	Observation
Stage Cleanout (CO #2) to Sump Pump	<ul style="list-style-type: none"> - Multiple joints separated - Debris throughout pipe - Survey abandoned 50' downstream of CO due to separated joint and large debris

- Replace sanitary sewer along north property line (CO#4 to Abbotsford Combined Sewer) and add new manhole on School side of property line at Abbotsford.

- Replace storm sewer along north property line (CO#1 to CB#2) and add new manhole at connection to existing sewer.
- Replace all sanitary sewer backflow prevention valves outside of the building footprint within manholes to allow easy access for maintenance and inspection.
- Repair or replace sanitary sewer within crawl space directly south of Skokie Ditch (MH#3 to end in building).
- Replace sanitary sewer from southeast corner of building towards Abbotsford Road (MH#8 to Abbotsford) due to large offset joint and obstruction.

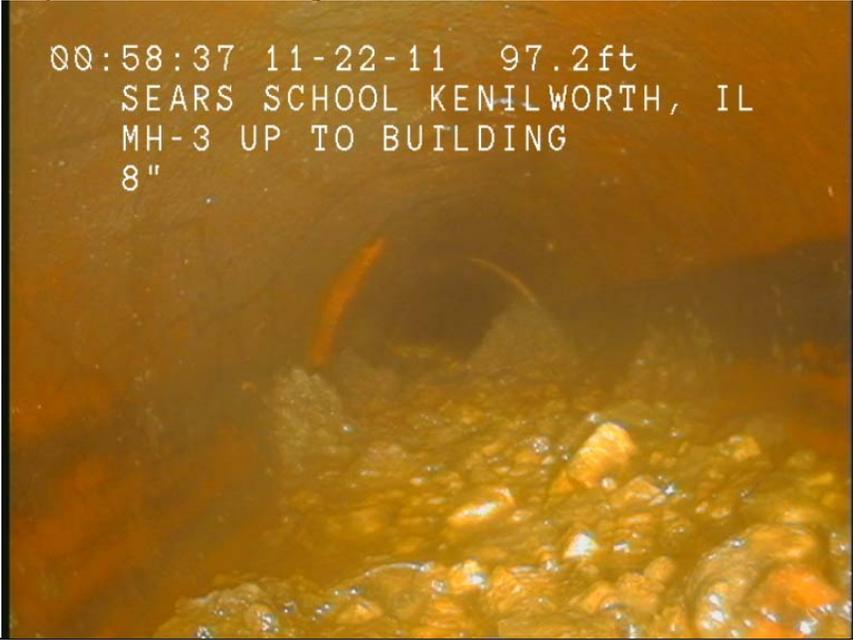
Sewer Observations	
Legend: CO = Cleanout MH = Manhole CB = Catch Basin	
Storm Cleanout (CO #1) to CB #2	<ul style="list-style-type: none"> - Debris throughout pipe. - Survey abandoned 55' downstream of CO due to debris
CB #2 to CO #1	<ul style="list-style-type: none"> - Many bends observed. - Roots at many joints - Debris throughout pipe - Survey abandoned at 30' due to debris and pipe sag.
Sanitary Cleanout (CO #4) to Abbotsford Combined Sewer	<ul style="list-style-type: none"> - Sag in line between 19' and 41' downstream of CO. - Survey abandoned due to debris and bends
MH #3 to Building	<ul style="list-style-type: none"> - Leaking joint (infiltration) at 50' upstream of MH #3. - Debris in line starting at 85' upstream of MH #3 to unknown. - Survey abandoned at 97' upstream of MH #3 due to debris. <div style="text-align: center; margin-top: 10px;">

</div>
MH #8 to Abbotsford Combined Sewer	<ul style="list-style-type: none"> - Sag begins at 36' downstream of MH #8. Gap in joint. - Survey abandoned at 38' downstream of MH #8 due to large joint separation. - Unknown obstruction at approximately 43' downstream.
